Low Voltage Assets and Control and Instrumentation EJP - Bacton FOSR Cost Re-Opener

October 2024

Issue: 3.0

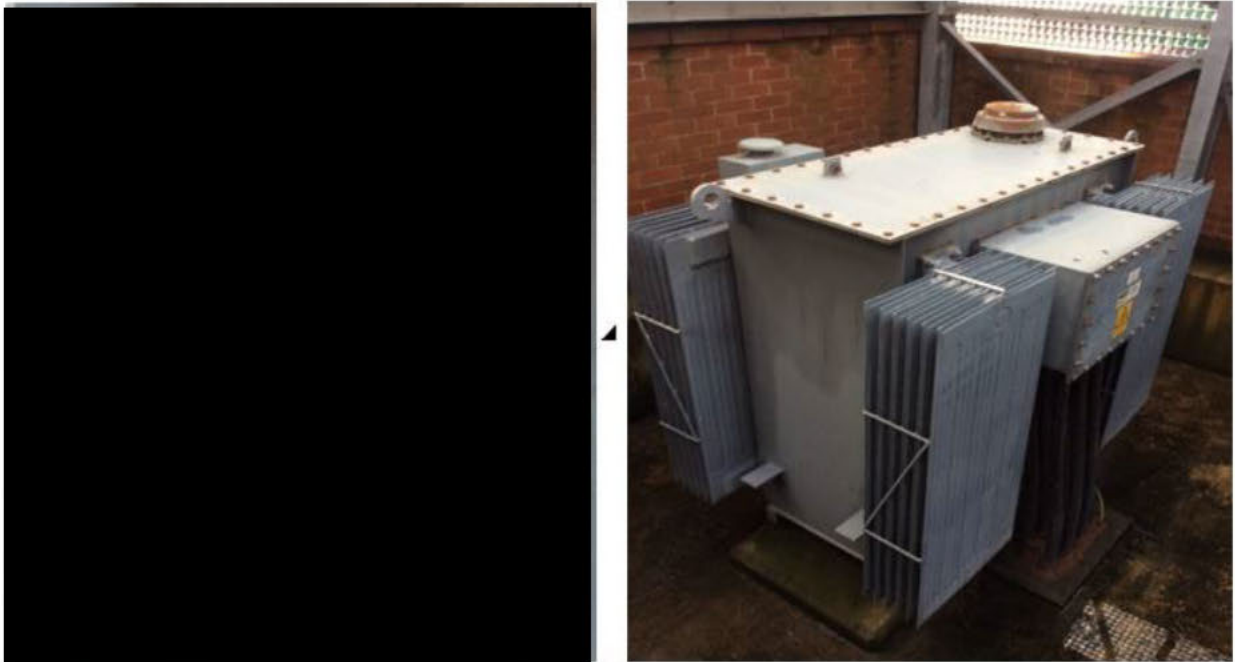
Figure 2: LV Transformers Technical Specifications (left) and Transformer picture (right)

Similarly, transformer degradation due to environmental conditions was first noted during a 3 yearly maintenance activity in 2016. We identified that the transformers needed patch painting, and a subsequent defect was raised. Patch painting was done

again in 2017/18 and as part of the one yearly visual, functional inspection, painting has been an on-going maintenance activity to date, however with Bacton being on a coastal location the assets have continued to deteriorate to a condition whereby they need to be replaced.

- 4.1.9 **Transformers** - Based on the 2024 oil diagnostics reports of TX1 and TX2, the onset of transformers insulation paper degradation has been confirmed by their Degree of Polymerization (DP) values. Results of the tests done in August 2024 revealed that TX1 and TX2 had a DP of 396 and 355, respectively. New paper insulation has a DP of above 1000 which gradually reduces as the paper ages. At a DP of 250, a transformer is considered to be at its end of life (EOL) within 5 years, at which point both assets would still need replacing. Without intervention, sudden transformer failure will result in loss of supplies to critical auxiliaries resulting in loss of terminal capability

Asset	Major Findings	Probability of failure statement
Transformers	TX1 and TX2 have confirmed paper insulation degradation of 389 and 437 respectively, which is approaching the design limit of 250.	Paper insulation is an integral part of a transformer and allowing DP to approach the limit is highly risky. It is highly likely that the transformers will be end of life before 2030.
Standby Generator	The Standby generator spares are now obsolete and affecting maintenance.	With the confirmed unavailability of maintenance spares from the OEM, there is high a probability of the having the generator unavailable due to a major defect.
UPS	Damage to sensitive downstream electronic equipment or control systems	Most of the UPS systems are affected by the unavailability of spares due to obsolescence issues. In the event of the Main UPS failing, there will be no power to critical assets such as Control Systems, Radio Communications, Flow Metering, Security & Access Control, Fire Sirens, Over Pressure Protection safety systems to name a few.

Replacement	<p>Involves the replacement of the two transformers with new units including upstream and downstream cabling.</p> <p>The civil and drainage assets will also be upgraded and/or redesigned to comply with NGT standards thereby addressing the environmental impact of the transformers</p>	<p>Will meet the terminal's long-term strategy where the transformers should be functional to 2050.</p> <p>This option significantly reduces the likelihood of equipment failure leading to the inability to flow gas through the terminal.</p> <p>This option is safer and complies with all the standards and regulations.</p>	<p>Highest cost in the short term, but low whole life cost.</p>
Standby Generator	Do Nothing	<p>No specific intervention to be undertaken save for the normal generator's maintenance using Operational Expenditure. This includes routine servicing, maintenance and start-up and run tests</p>	<p>Relatively low or no capital spend (but with increasing OPEX spend for more intrusive and re-active maintenance as asset continues to deteriorate</p>	<p>Risk of failing to run the generators owing to spares obsolescence.</p> <p>Failure to run the generator when needed results in the unavailability of the Terminal until normal supplies are availed.</p> <p>Damage to sensitive loads across the site (C&I equipment) that will impact on the operation of the site.</p>

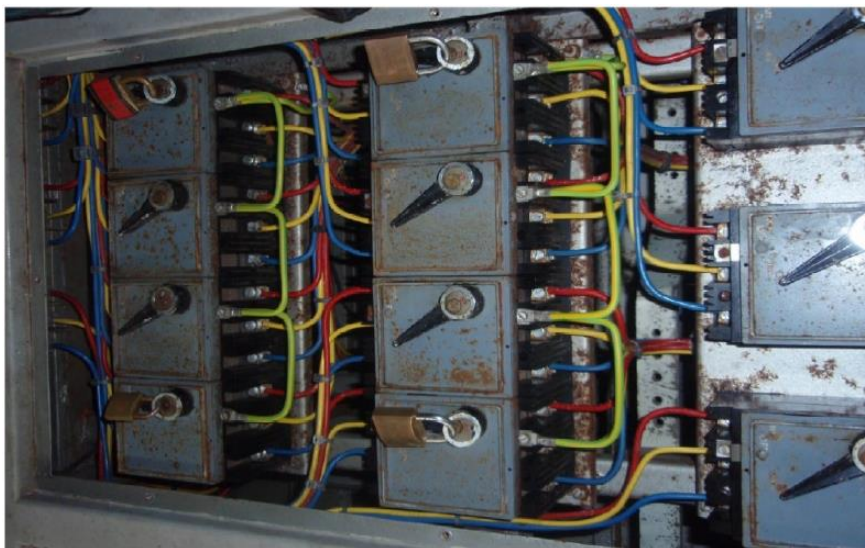
Figure 4: Typical Distribution Panel

- 3.1.19 The site has several Kiosks that contain electrical distribution panels located around the site that supply various pieces of electrical equipment. Specifically covered in this scope are Kiosks C, D, E, F and G which have known asset health issues. These kiosks house supplies to about 56 actuators each, Cathodic Protection power supplies, lights and sockets making them critical to site operations. Figure 4 shows an example of a distribution panel housed in one of the Kiosks.
- 3.1.20 By design and purpose, electrical kiosks have no redundancy and should be refurbished or replaced once they lose their weather-resistant and fire-retardant properties which protect internal assets.

Replacement	This option involves the complete replacement of identified DBs with new ones.	Reduction of operational risks such as arc flashes to ALARP as well as enabling compliance with latest safety and quality standards.	Highest cost in the short term, but low whole life cost. The replacement process typically involves much long lead times and a more complex installation process as compared to retrofitting.
External Lighting	Do nothing	Entails no immediate investments on the lights, but continuous repair and replacement on failure	Relatively low or no capital spend (but with increasing OPEX spend for more intrusive and re-active maintenance as asset continues to deteriorate	Poor illumination is often cited during investigations into trips, slips and falls alongside uneven terrain. If lighting is not in a suitable condition and / or suitably zone-rated in accordance with EAWR and / or DSEAR, additional consequences could occur which may pose a significant risk to health and safety.

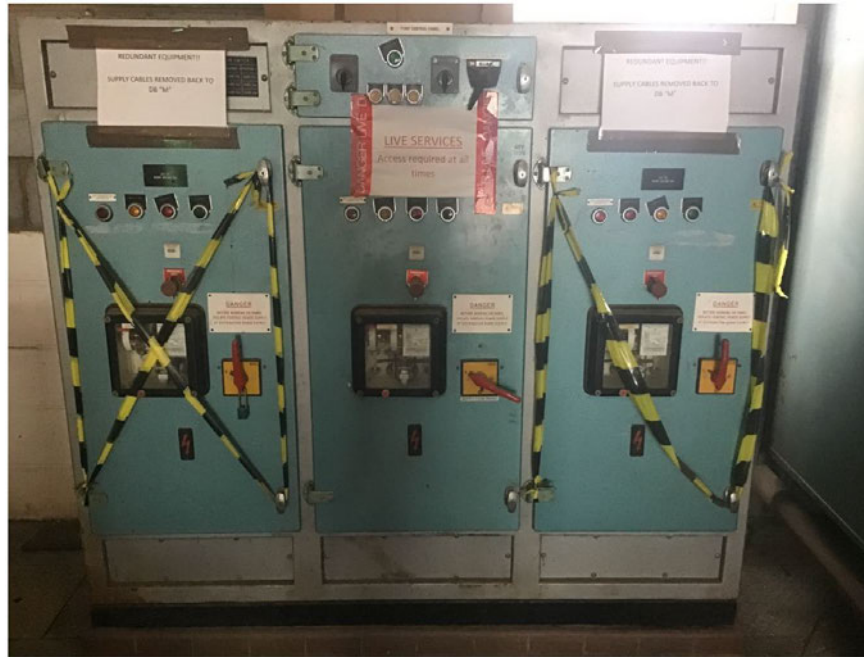
Figure 5: Pump control panel 1

- 4.1.11 **Pump Control Panel 1** – This control panel was manufactured more than 40 years ago by [REDACTED] who are no longer trading thereby presenting obsolescence issues. The panel has been heavily affected by the unavailability of spares and is currently in a status shown in Figure 7. Failure of the pump control panel would result in inoperability of the fire-water system, which is a critical component of both our own and Interconnectors Safety-Case Commitments.

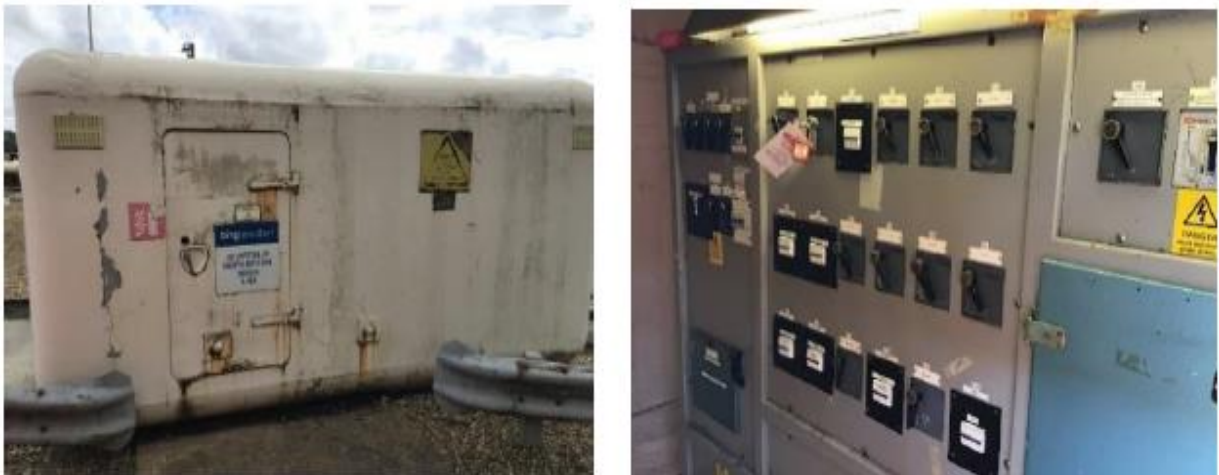
Figure 6: Kiosk F (left) and panel (right)

4.1.12 **Kiosk F** - It is a panel board split into two with a single feed from switchboard A and another from DB B. It currently feeds several valve actuators, small power, and external lighting. BPG Engineering are no longer trading so no further technical assistance can be obtained. Water ingress to kiosk and signs of condensation and rusting are significantly evident. The current status of the kiosk is shown on Figure 8. If no investment is done, the continuous ingress on moisture in the kiosks will result in electrical failures on the panels and failure to supply power to the outgoing circuits to the safe control and operation of Terminal gas flows.

4.1.13 Section 8 of the Bacton [REDACTED] Electrical Report (Appendix C) gives detailed findings of the condition of each kiosk covered in this EJP. If the valves cannot be operated, we are notable to safely control, isolate or regulate gas flow through the terminal, as they will not automatically go into a safe state as they need motive electrical power to do so.

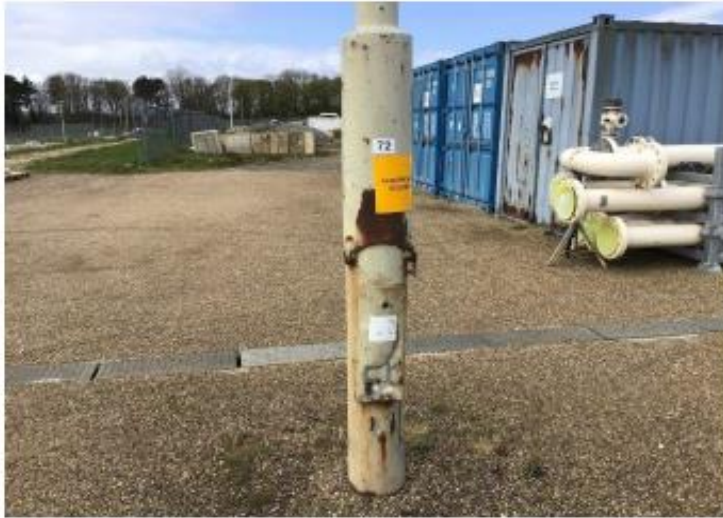
Figure 7: Typical lighting column

- 3.1.24 There is evidence of significant corrosion across the terminal lighting columns. There has been corrosion identified within the cam pivot section of the columns, this has led to the columns being unsafe to lower. When a lamp / light fitting requires maintenance or repair, the activities are carried out with the use of Mobile working elevation platform (MWEP) which presents an added safety risk of working at height. This adds additional OPEX cost to all activities associated with lighting columns.

4.1.14 **External Lighting** - The current [REDACTED] base hinged columns are in poor condition and have been condemned by the manufacturer. Light fittings are SON/MH lamp type, and the majority of the underground cabling is direct buried. Figure 7 shows one of the lighting columns which is heavily corroded. DSEAR defects, such as flame path damage and armour cable showing are prevalent across all the lighting columns. DSEAR defects increases the likelihood of a gas release being ignited which poses a safety risk to site personnel. Cable defects also present a substantial risk of electric shock.

Replacement of lights	This option focusses on the replacement of lights and fittings with the columns in situ	Improves luminance at a low cost	The risk of column and cable failures due to age-based deterioration is not addressed.
	Complete Replacement	This option entails the replacement of the entire column, lights, and cabling	Opportunity to improve terminal luminance with compliant, latest technology and efficient lighting.	Highest cost in the short term, but low whole life cost
