# NGT\_AH2\_04

## St Fergus Above Ground Pipework Corrosion

Engineering Justification Paper

June 2023

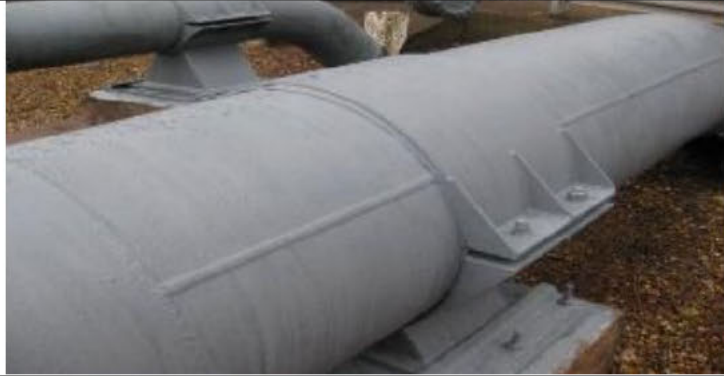
Visual Grade	Description	Example	
1: No remedial action required	No risk of onset corrosion

Paint system in 'as new' condition with no evidence of paint degradation or algae formation

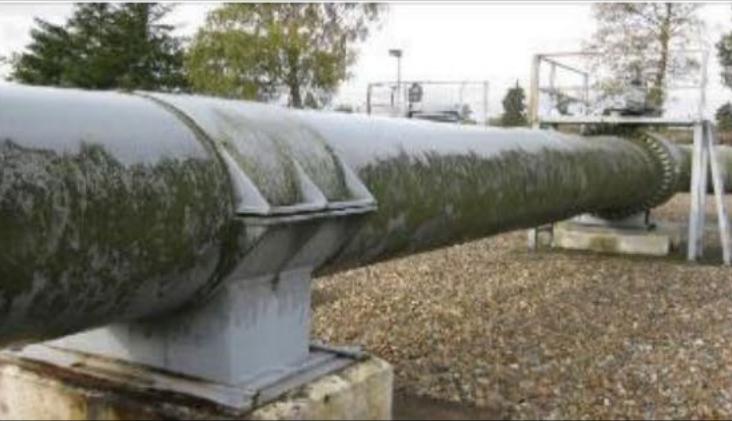
2: No remedial action required	Low risk of onset of corrosion

Paint system in good condition with only superficial coating deterioration (e.g. chalking) or algae formation. Areas may require power wash to remove algae (if present) to confirm corrosion is not being concealed.

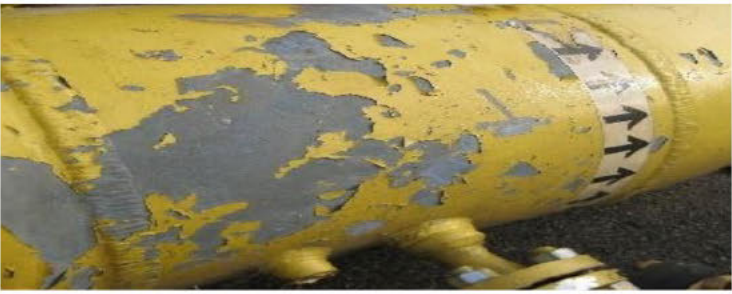
3: No remedial action required	High risk of onset of Corrosion

General breakdown or widespread defects in the paint system (e.g. top-coat cracking or flaking) but no visible rust staining or corrosion products. Areas may require power wash to remove algae (if present) to confirm corrosion is not being concealed.

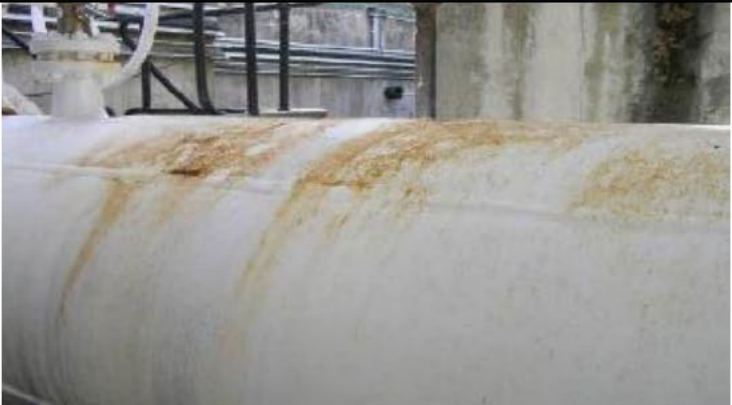
4: Remedial action required	Corrosion present  Possible risk of P/11 or P/20 defects

Paint system in fair condition with some small areas of paint breakdown leading to rust staining but no other visual signs of corrosion. Patch repair techniques are likely to be cost effective.

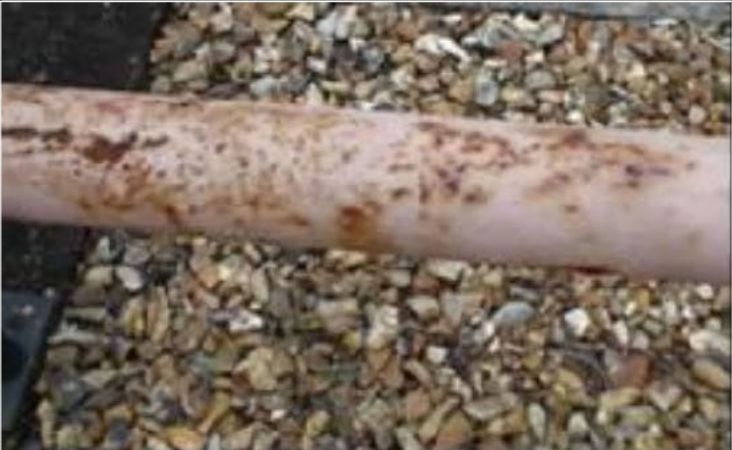
Visual Grade	Description	Example	
5: Remedial action required	<p>Active corrosion present</p> <p>Credible risk of P/11 or P/20 defects</p>

<p>Paint system in poor condition, with areas of brown coloured corrosion products present, often with associated rust staining.</p> <p>Consideration should be given for full repaint as patch repair may not be economical.</p>
6: remedial action required	<p>Aggressive corrosion present</p>

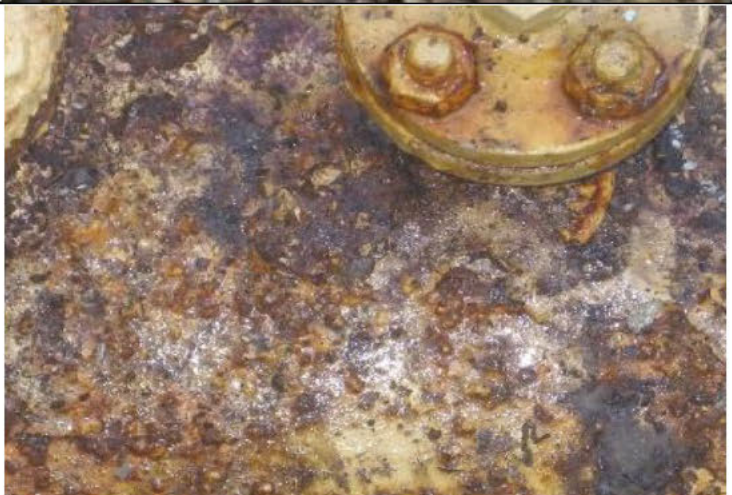
<p>Paint system in poor condition, with localised areas of black coloured corrosion products present which can result in rapid metal loss.</p> <p>Areas are likely to require a full repaint. Leaking damage shall be isolated and addressed immediately.</p>

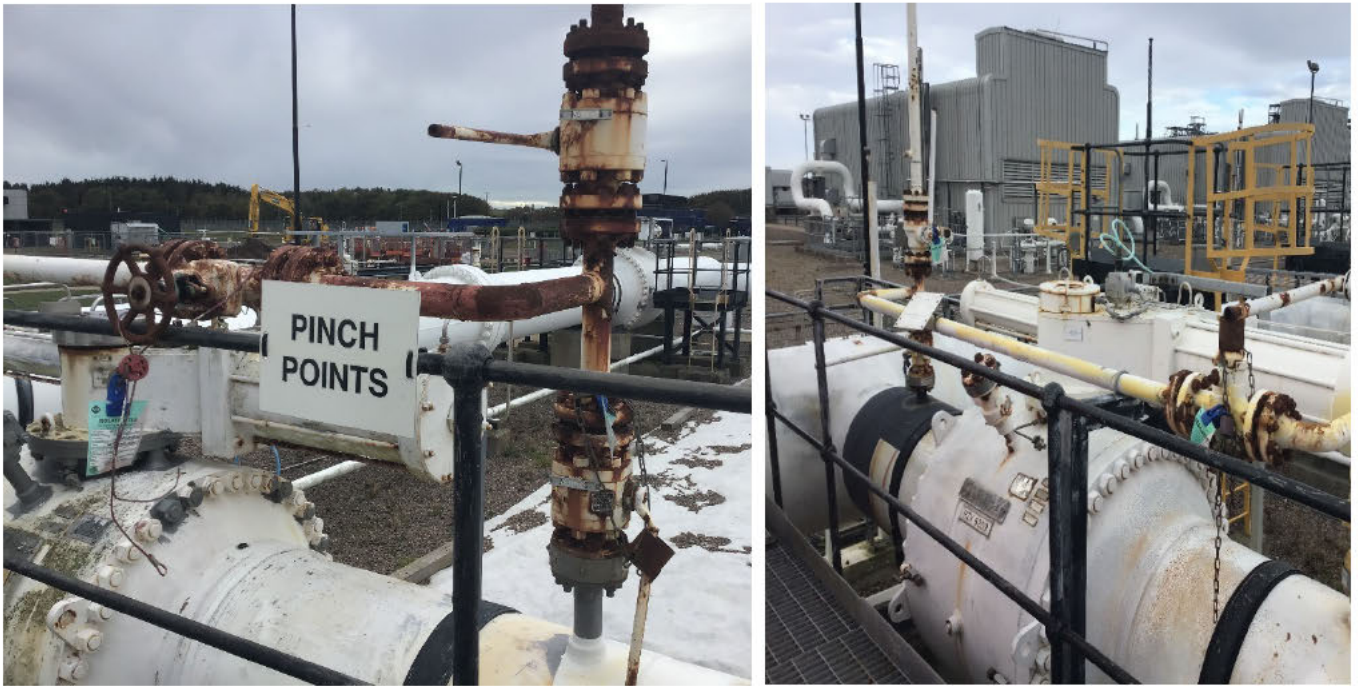
68. As will be discussed later in the document, areas 3 and 6 have been prioritised for intervention based on the poor condition of the coating and severity of corrosion. The images in Figure 7 further showcase the condition.

**Figure 7 Category 6 corrosion defects on above ground pipework in the mixing area (located in area 6) of the terminal**
