NGT_AH2_03

St Fergus

HV Transformers

Engineering Justification Paper

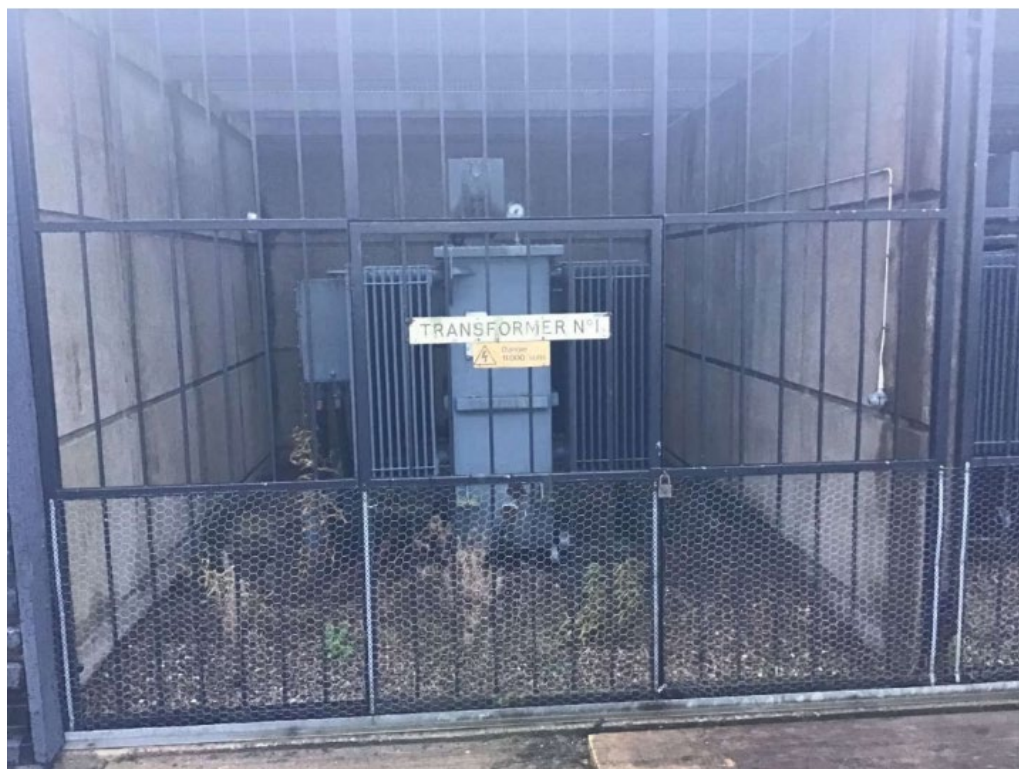
62. Currently BGC/T1, P1/T1 and P2/T1 have been isolated from plant operating service. P1/T1 oil was drained after severe corrosion on the transformer body caused an oil leak in 2020. This transformer was inspected and deemed damaged beyond repair as the internal components of the transformers were also severely corroded.

Figure 7 Plant 1 T1 transformer 1 currently isolated

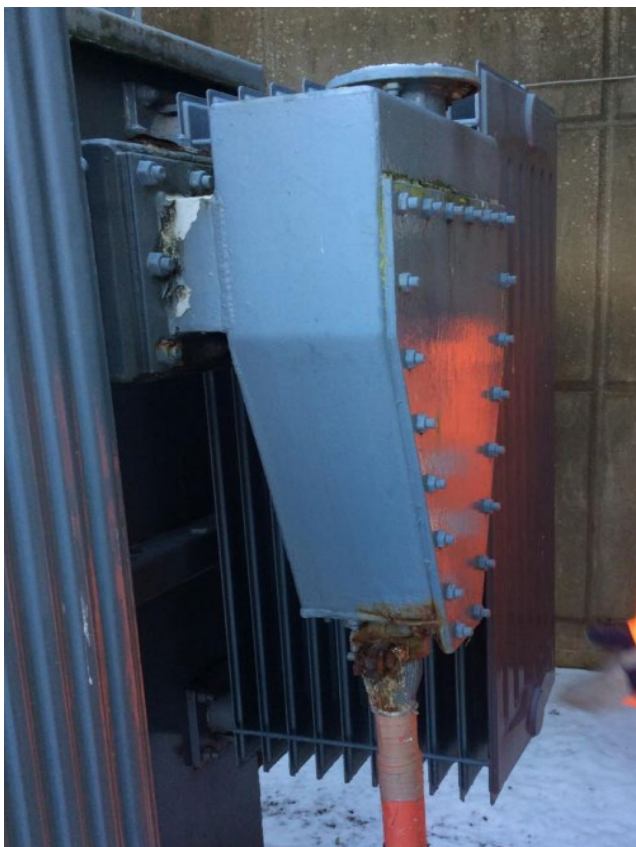
64. All remaining transformers are also in severely bad condition where corrosion and leakage can be identified on the tank and radiator fins. Paintwork on the transformers is very rusty and flaking off as seen in figure 8 and 9.

65. The visual inspection concluded that where the HV cables have been exposed to the environment, the cable insulation sheath is showing deterioration and cable glands were showing corrosion.

Figure 8 Corrosion on the radiator fins and connecting cables

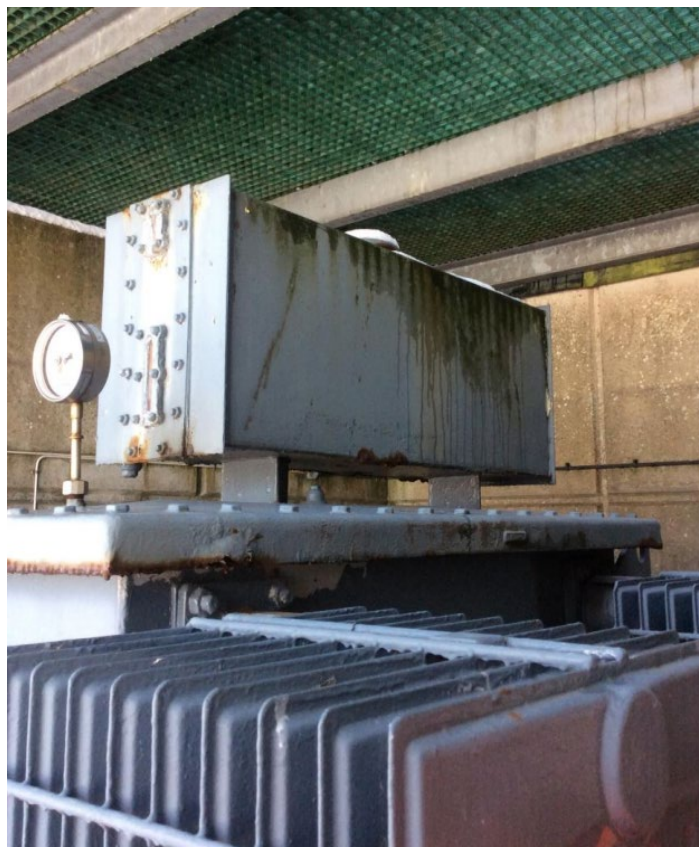
Figure 9 Leaking oil from conservator tank and corrosion
