NGT_AH2_04

St Fergus Above Ground Pipework Corrosion

Engineering Justification Paper

June 2023

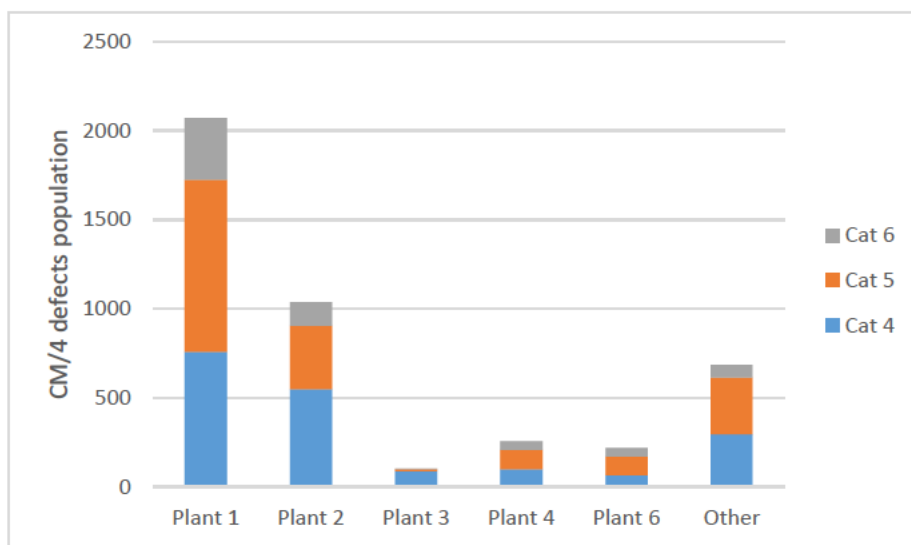
- 56. Over five years, visual inspections and reporting of above ground coating surveys carried out across the site during maintenance activities have identified over 4,000 corrosion defects as shown in Figure 6.

Figure 6 Defect population recorded at St Fergus as of 2021

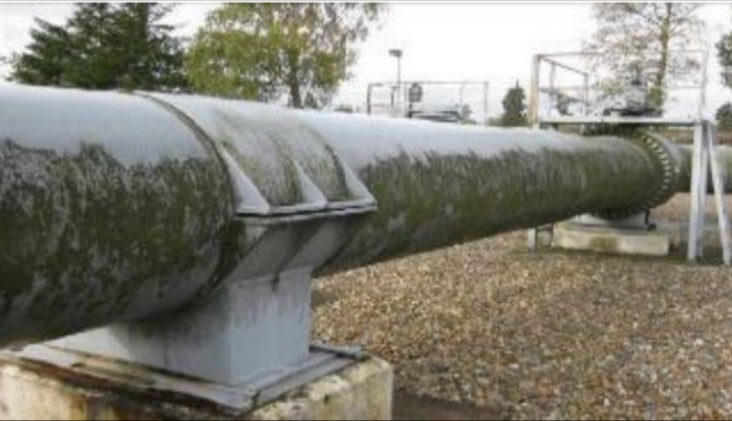
2: No remedial action required	Low risk of onset of corrosion

Paint system in good condition with only superficial coating deterioration (e.g. chalking) or algae formation. Areas may require power wash to remove algae (if present) to confirm corrosion is not being concealed.

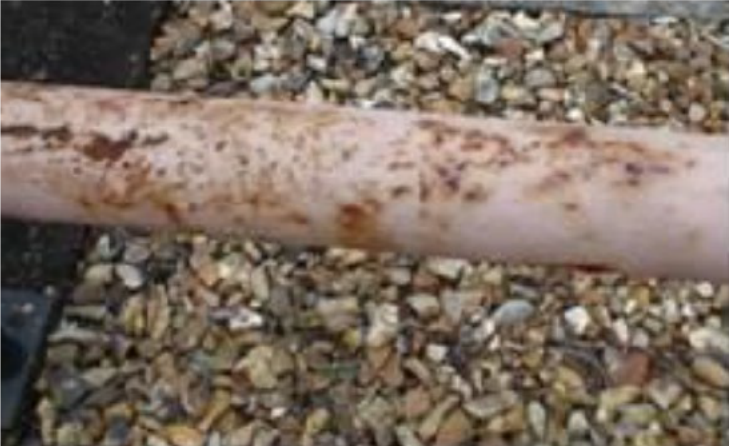
Visual Grade	Description	Example	
5: Remedial action required	<p>Active corrosion present</p> <p>Credible risk of P/11 or P/20 defects</p>

<p>Paint system in poor condition, with areas of brown coloured corrosion products present, often with associated rust staining.</p> <p>Consideration should be given for full repaint as patch repair may not be economical.</p>
6: remedial action required	<p>Aggressive corrosion present</p>

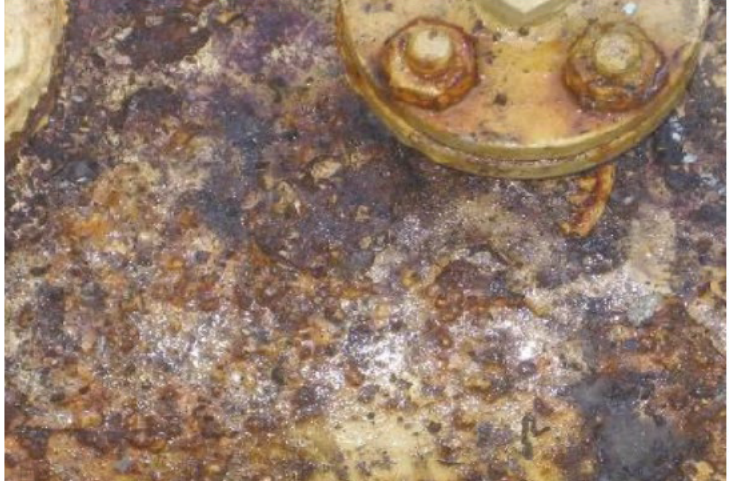
<p>Paint system in poor condition, with localised areas of black coloured corrosion products present which can result in rapid metal loss.</p> <p>Areas are likely to require a full repaint. Leaking damage shall be isolated and addressed immediately.</p>

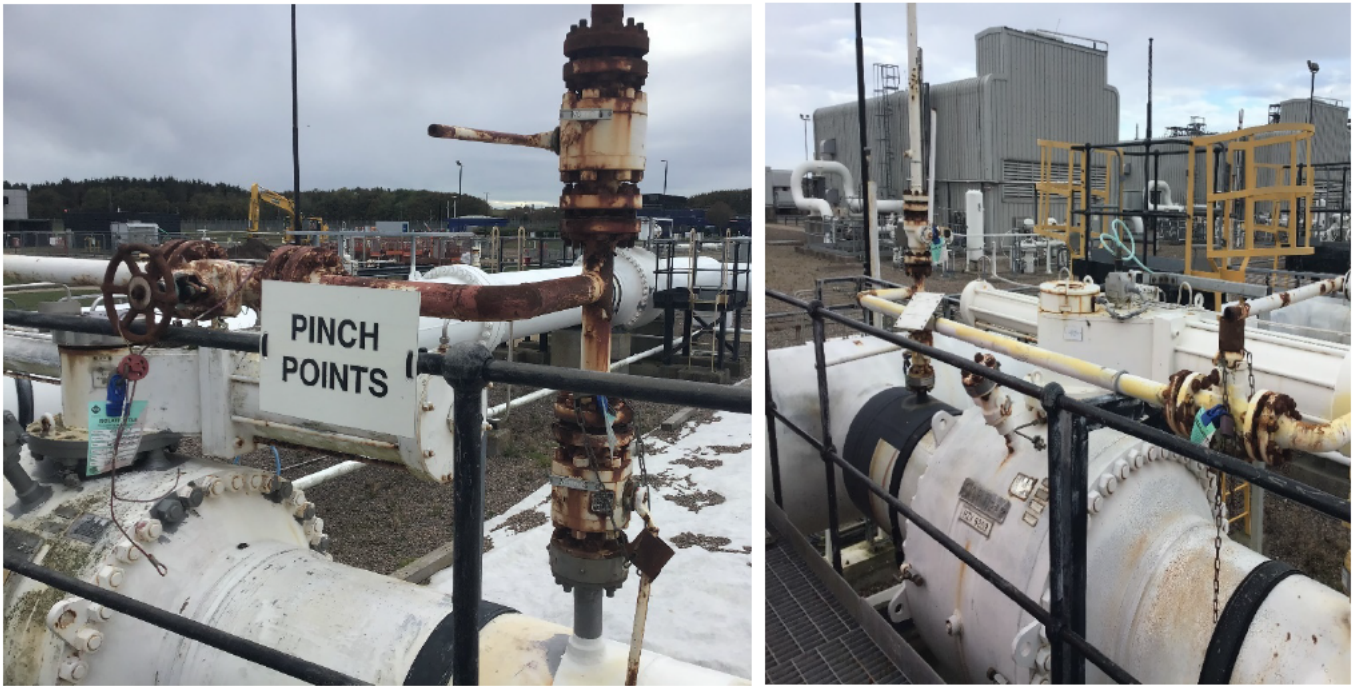
68. As will be discussed later in the document, areas 3 and 6 have been prioritised for intervention based on the poor condition of the coating and severity of corrosion. The images in Figure 7 further showcase the condition.

Figure 7 Category 6 corrosion defects on above ground pipework in the mixing area (located in area 6) of the terminal
