# NGT\_AH2\_04

## St Fergus Above Ground Pipework Corrosion

Engineering Justification Paper

June 2023

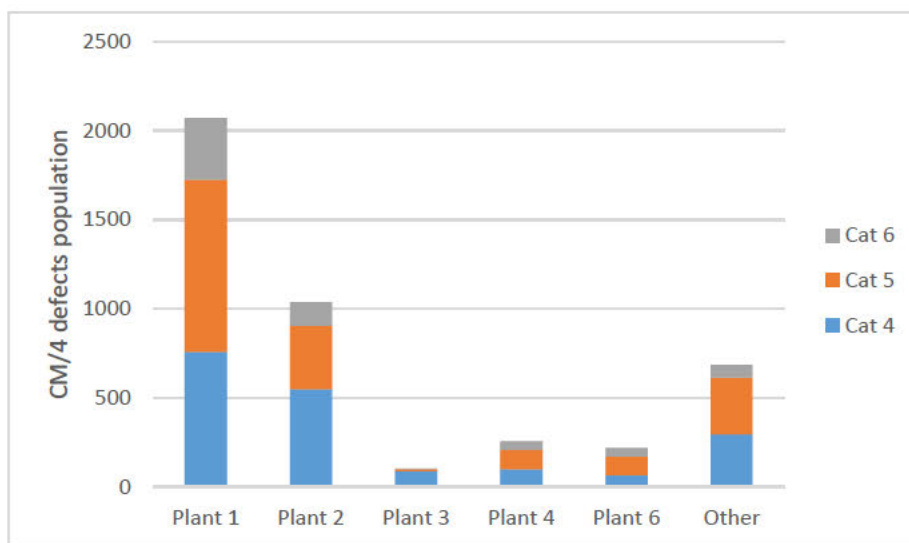
Figure 6 Defect population recorded at St Fergus as of 2021

- 56. Over five years, visual inspections and reporting of above ground coating surveys carried out across the site during maintenance activities have identified over 4,000 corrosion defects as shown in Figure 6.

- 57. Corrosion defects are more prevalent in areas such as: underneath pipe supports, at the transition from above to below ground (either at a pit wall or the wind/water line), in congested areas subject to stagnant air or on specific elements (such as flanges or small-bore pipework). This is due to accelerated corrosion mechanisms that tend to play out in these environments.
- 58. The HSE have recognised that managing the integrity of ageing plant and equipment is a key issue for the industry, in particular degradation due to corrosion, erosion, and fatigue.
- 59. Maintaining our current reactive approach will ultimately result in a growing number of corrosion defects, exceeding the capacity to address them in timely manner.

- 55. To address corrosion defects throughout the terminal, a combination of patch painting and partial painting interventions have been utilised. Regrettably, this approach is no longer sustainable given the environment in which these assets are exposed which results in an escalating number of defects observed across the terminal.
