NGT_AH2_14

Cab Infrastructure and Fire Suppression

Engineering Justification Paper

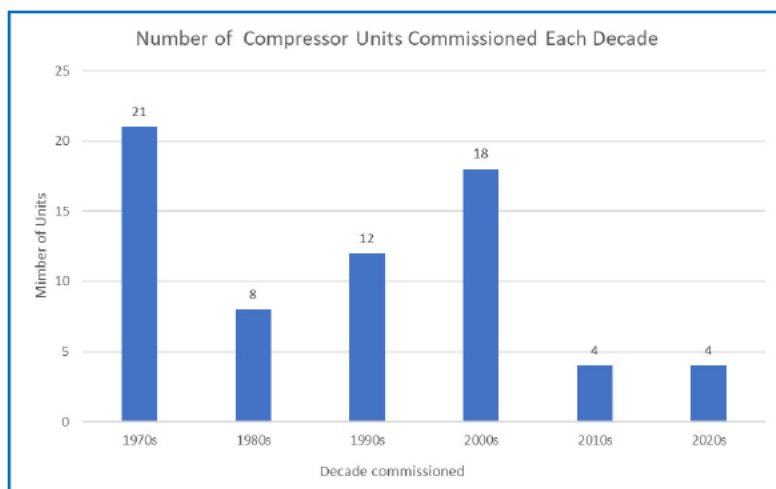
3.1.3 Figure 2 shows which decade compressor units were commissioned in. As a general rule, cab infrastructure and fire suppression systems associated with compressor units commissioned before 1990 don't comply to modern standards and require significant upgrades to operate safely and efficiently. Units commissioned after the late 1990's are mostly compliant with modern standards and will require fewer design changes but will still have defects that need to be solved due to deterioration over time.

Figure 2: Number of compressor units and associated cab infrastructure & fire suppression commissioned in each decade

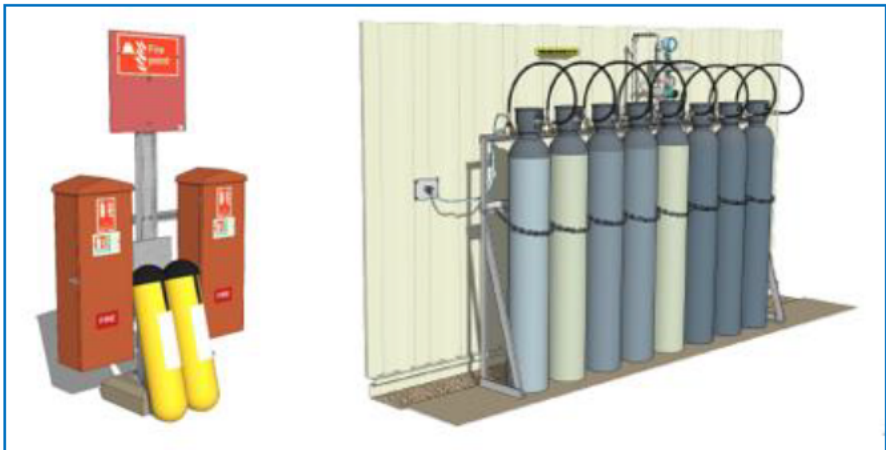
3.3.3 Fire suppression systems are permanently installed on every gas generator enclosure on sites across the NTS. Where the fire suppression is not available the compressor cannot be operated. Figure 7 depicts typical fire suppression systems on the NTS.

Figure 7: Cabs Fire Suppression (Fire point and Pressurised nitrogen bottles for HI-FOG® system)

3.3.5 There are typically two banks of nitrogen bottles, primary and reserve for each compressor cab with a manual changeover to allow for maintenance, repair and refurbishment and availability following a discharge of the primary bank. No automated change-over exists so any failure of the primary systems impact the availability of the whole compressor unit.
