NGT_AH2_14

Cab Infrastructure and Fire Suppression

Engineering Justification Paper

June 2023 (updated Sept'23)

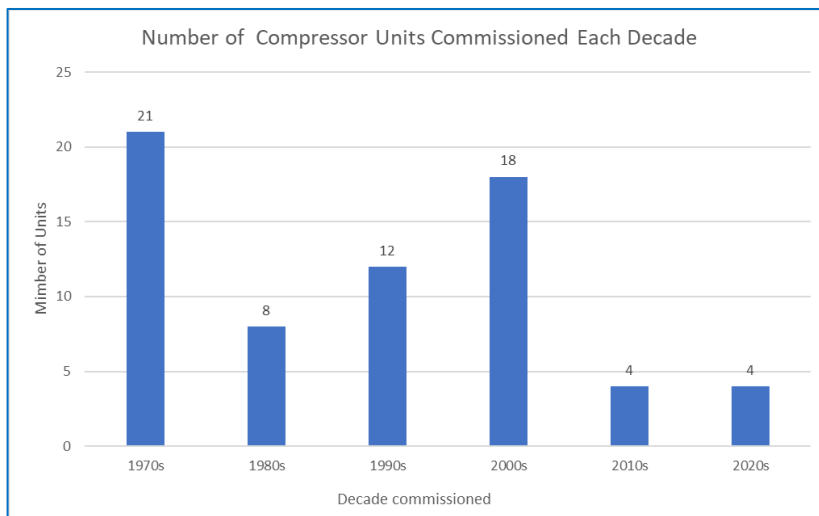
Figure 2: Number of compressor units and associated cab infrastructure & fire suppression commissioned in each decade

3.1.3 Figure 2 shows which decade compressor units were commissioned in. As a general rule, cab infrastructure and fire suppression systems associated with compressor units commissioned before 1990 don't comply to modern standards and require significant upgrades to operate safely and efficiently. Units commissioned after the late 1990's are mostly compliant with modern standards and will require fewer design changes but will still have defects that need to be solved due to deterioration over time.

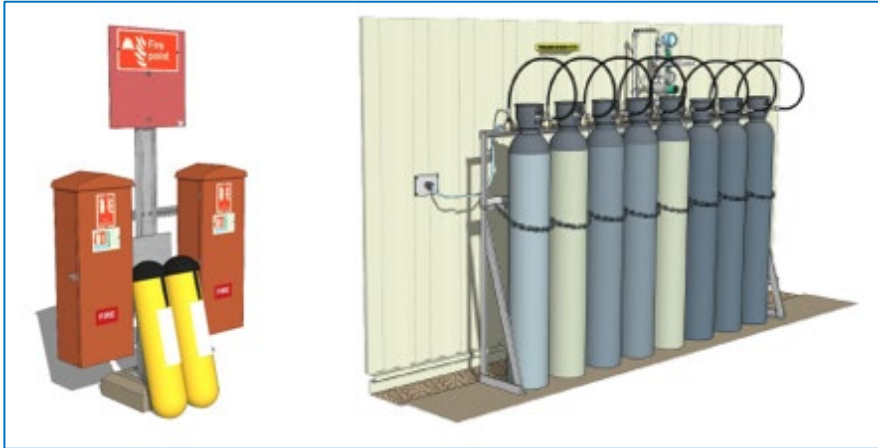
Figure 7: Cabs Fire Suppression (Fire point and Pressurised nitrogen bottles for HI-FOG® system)

3.3.3 Fire suppression systems are permanently installed on every gas generator enclosure on sites across the NTS. Where the fire suppression is not available the compressor cannot be operated. Figure 7 depicts typical fire suppression systems on the NTS.

- 3.3.1 The Fire Suppression Systems –extinguish any fires within the enclosure preventing escalation and minimising safety and environmental risk and plant and associated plant damage. The condition of these assets is critical. There are three main types of fire suppression:

- **200 bar nitrogen bottles** directly pressurise water bottles, forcing the water through spray heads into the enclosure – for smaller older enclosures with four to 15 spray heads.
- **200 bar nitrogen bottles drive a gas driven pump** that takes water from a large water tank and forces it through spray heads into the enclosure; these can protect large volumes but require approximately 30 nitrogen bottles for each fire that must then be replaced.
- **Electric motor driven pumps** take water from a larger water tank. These remove issues with nitrogen but require electric supply infrastructure to be installed which would include any necessary power generation backups.

- A temperature-controlled enclosure including thermostat and electric heater to maintain bottles at suitable temperature to avoid a pressure drop and to stop water from freezing.
- 200bar Nitrogen or a nitrogen/electric driven pump.
- Water cylinders or a bulk water storage tank.
- Discharge manifold, distribution piping and spray heads (stainless steel).
- Electrical solenoid actuator valves.
- Pneumatically actuated slave valves.
- Pressure switches (to monitor nitrogen cylinder pressure and confirm system operation).
- High pressure flexible hoses.
- System isolation valve and limit switch.
- A changeover switch from main to reserve system.
- Some utilise a pump unit and water storage tank rather than water cylinders.

3.3.5 There are typically two banks of nitrogen bottles, primary and reserve for each compressor cab with a manual changeover to allow for maintenance, repair and refurbishment and availability following a discharge of the primary bank. No automated change-over exists so any failure of the primary systems impact the availability of the whole compressor unit.

- 4.2.6 **Fire suppression deterioration:** Elements of the assets are deteriorating due to age, corrosion, and wear. Increasing defect numbers are being recorded and the assets are becoming unreliable and fail to work when called upon. As systems age, deposits in pipework, bottles and hoses repeatedly block spray heads which reduce effectiveness.
