RIIO-T2 Re-opener

St Fergus Valve Actuators

**Engineering Justification Paper
January 2023**

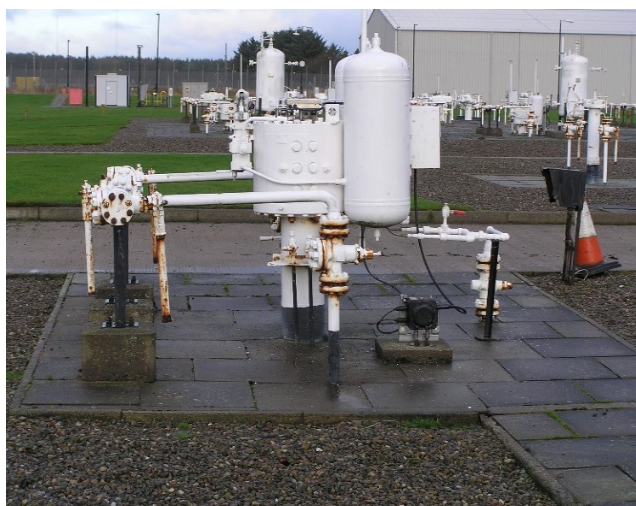
Figure 3: Typical gas-powered Actuator at St Fergus terminal

3.2 A site wide valve actuation system powered by a single gas actuating pipework operates numerous safety valves, emergency shut down systems, vent systems, automated start-up and shut down processes and isolation valves. In total the gas actuating pipework system currently provides the power for the operation of 143 gas-hydraulic Shafer Actuators across the terminal, critical to its safe operation.

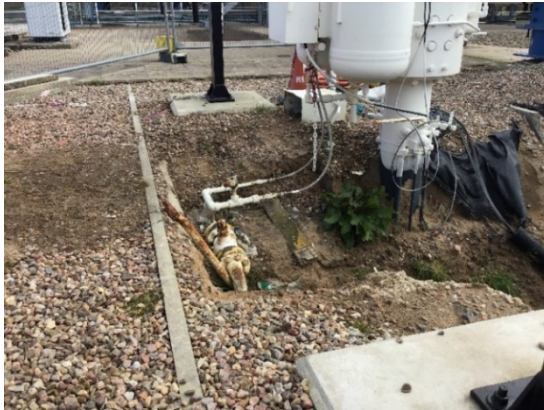
Figure 44: Corrosion and ground movement threats to Actuators

4.14 To demonstrate the scale and complexity of pipework defects a range of typical examples is shown below:

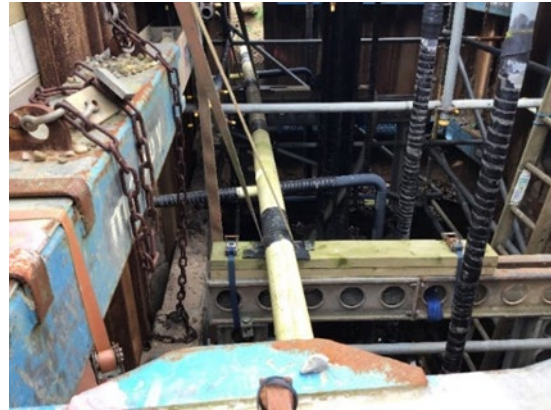
Figure 5: Temporary structure mitigating risk from clashing Actuator gas pipework movement

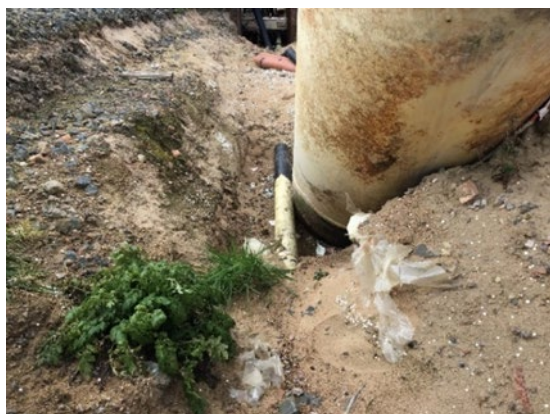
Figure 6: Actuating pipe clashing with main gas line due to ground movement

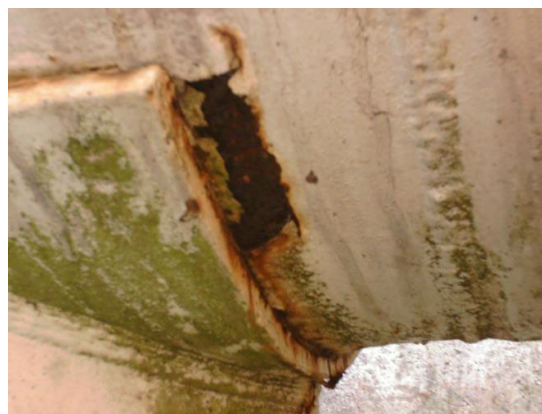
Figure 7: Corrosion under pipe support - a difficult failure to identify

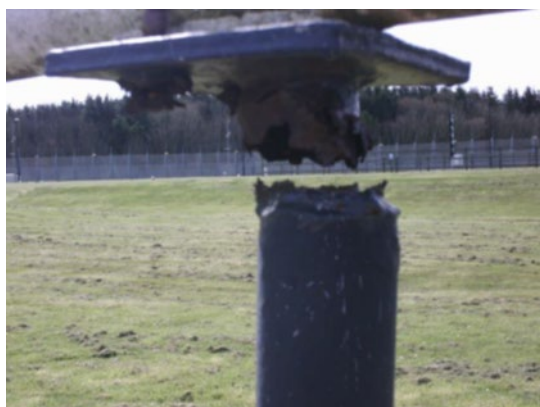
Figure 8: Damaged pipe support through corrosion and movement

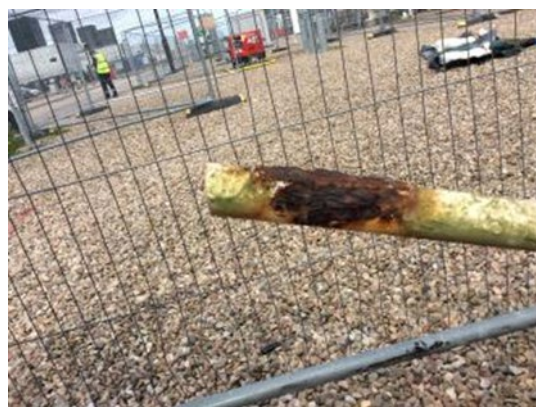
Figure 9: Through wall corrosion requiring replacement to continue operation

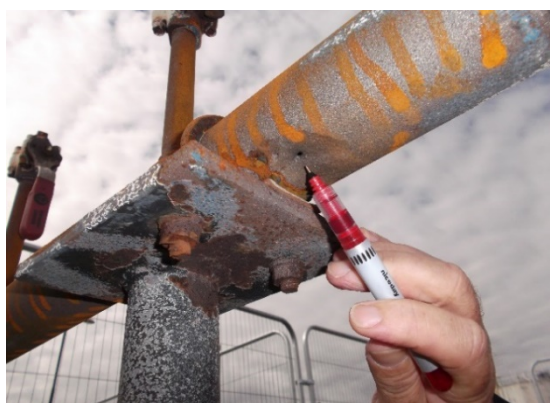
Figure 10: Through wall corrosion leading to pinhole leak requiring replacement

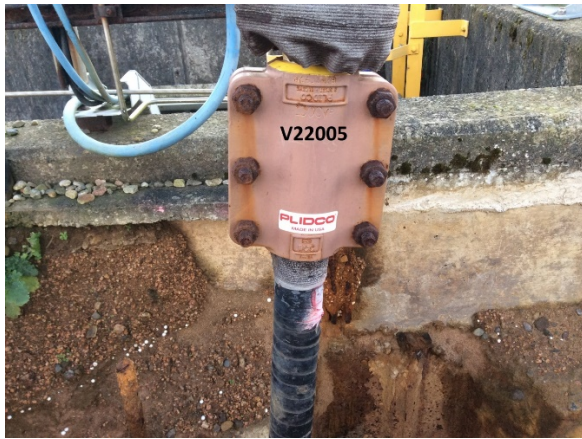
Figure 11: Temporary Plidco Clamp on Actuating pipework riser

4.15 Due to the original design of the Actuating pipework, gaining isolation to repair defects on many sections of the system is not possible without shutting down significant portions of the entire terminal. As such, nine separate Plidco Clamp repairs (see register in Appendix 6) have been implemented to manage significant corrosion defect risks and avoid significant plant outages to repair on the Actuating pipework. These repairs are deemed temporary and as such will need to be cut out and replaced if the Actuating pipework is to remain in use.

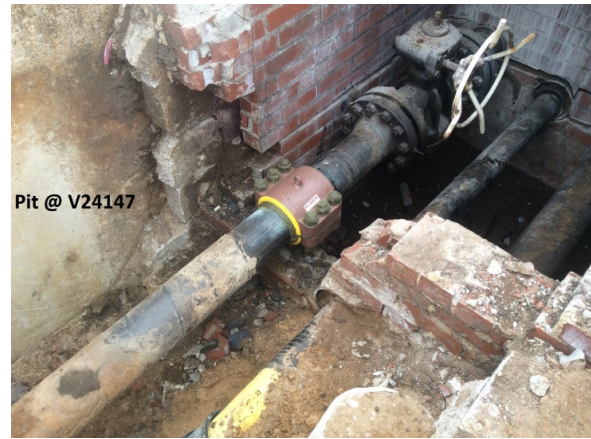
Figure 12: Temporary Plidco Clamp on Actuating pipework at pit wall transition

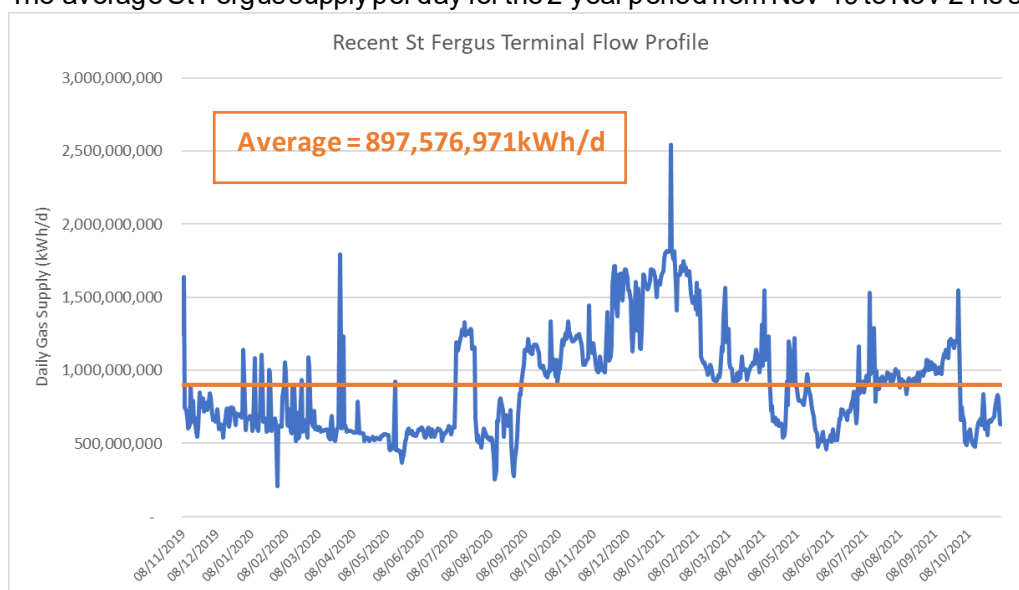
Figure 13: St Fergus Terminal flow profile

6.3 The average St Fergus supply per day for the 2-year period from Nov-19 to Nov-21 is shown below.

6.4 The average daily supply from St Fergus terminal over the last 2 years is 897,576,971kWh/d, utilising the constraint cost assumption of [REDACTED] equates to an average daily constraint cost of [REDACTED].
